# ANALYSIS OF ACCIDENTS OF THE TU-154 AIRCRAFT

Jacek F. Gieras

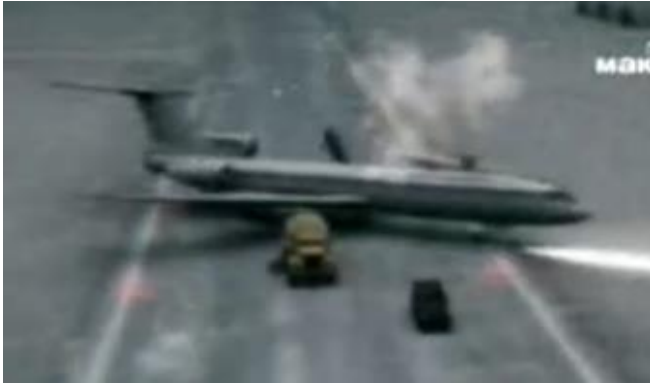
An example of disorder, negligence and lack of responsibility is the accident at Tolmachevo Airport. Omsk, Southwest Siberia on October 11, 1984 (Tab. 2) [5]. One of the controllers had fallen asleep and thus failed to inform the approach controller about the presence of snow vehicles on the runway. On touchdown, the flight crew of the Tu-154B-1 CCCP-85243 saw the array of vehicles and attempted to turn the aircraft, but were unable to avoid the collision. The

plane crashed into the Ural truck and then 200 m down the runway crashed into the KrAZ<sup>1</sup> truck, igniting the 7 t of fuel in each truck and the aircraft's fuel tank (Fig. 1). The plane overturned and broke into pieces, some of which crashed into the UAZ-469<sup>2</sup> all-terrain vehicle. A catastrophic fracture of the fuel tanks caused burning fuel to leak into the fuselage, incinerating all but one passenger. The cockpit section detached and flew past the burning vehicles. It suffered no major damage, and all four crew members survived, suffering only minor injuries. Four ground maintenance crew were killed instantly inside the vehicles. One survivor in the passenger seat of the UAZ-469 caught on fire, which was extinguished.

**Fig. 1.** Fatal accident of the Tu-154B-1 CCCP-85243 at Tolmachevo Airport, Omsk, Siberia on October 11, 1984.

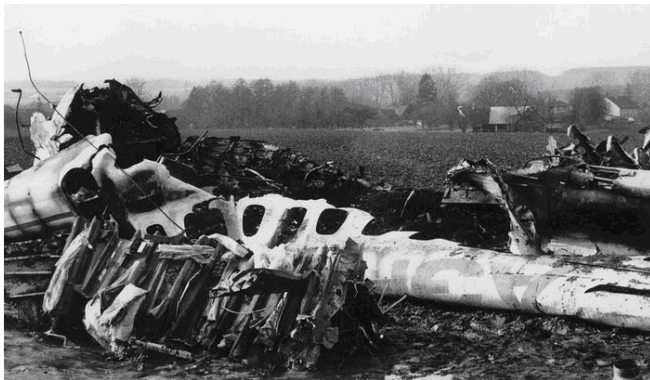
**Fig. 2.** Wreckage of Tu-154M CCCP-85664 burned out near Velichkovsky, the Republic of Czech on November 11, 1990.

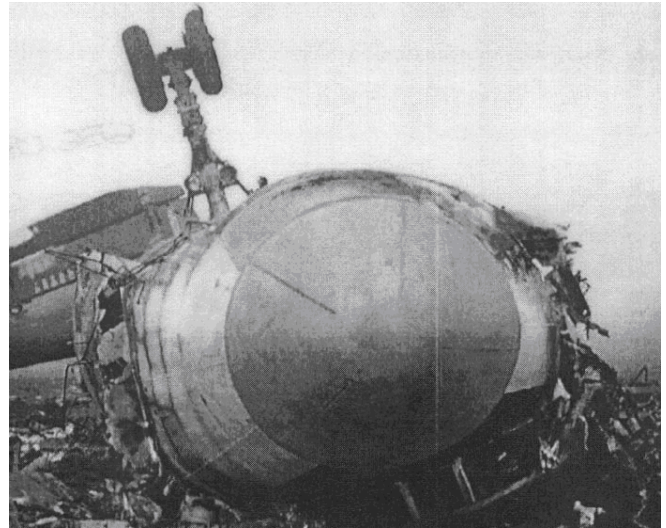
**Fig. 3.** Wreckage of the Tu-154B UK-85533 at New Delhi Airport on January 19, 1993.

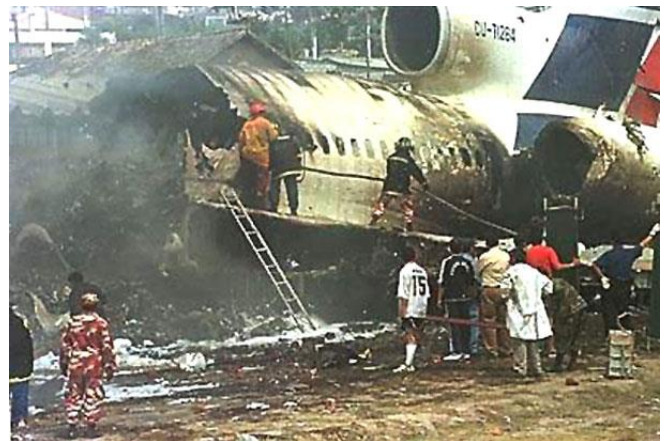
**Fig. 4.** Tail section of the Tu-154M CU-T1264 at Quito-Mariscal Sucre Airport on August 29, 1998.

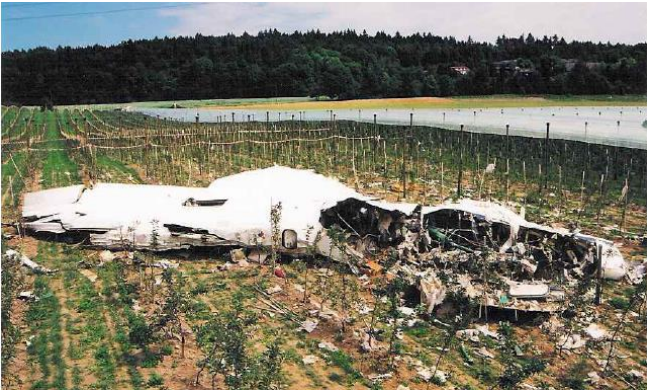
**Fig. 5.** The forward fuselage section of the Tu154M RA-85816 (Uberlingen mid air collision July 1, 2002) found at apple plantation near Brachenreuthe (Lake Constance) [6].

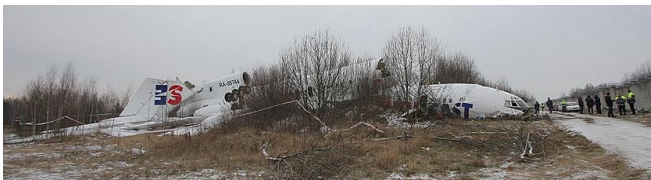
**Fig. 6.** The Tu-154M RA-85744 with its fuselage broken into three pieces at Domodedovo airport on December 4, 2010 [7].

The Tu-154M landed hard and struck a small earthen mound, causing the fuselage to split into three parts (Fig. 6). The crash caused the death to only two people and the injury to 86 people out of 163 passengers and 8 crew members [5].

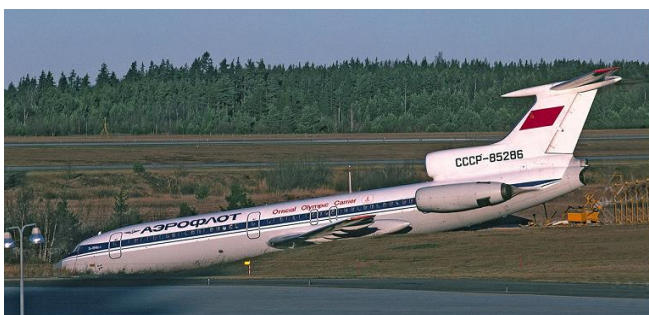
The Tu-154B1 CCCP-85286 (Tab. 8) scheduled from Stockholm to Moscow on November 14, 1978 had reached rotation speed VR when the captain felt firm resistance while trying to lift the nose. The crew decided to abort the take off with only about 500 m of runway left but the speed was too high to stop. The aircraft overran the runway at Stockholm Arlanda Airport, struck an ILS<sup>4</sup> localizer antenna and crashed after the nose failed to lift up and stopped in a embankment side (Fig. 7) [2-5]. There were 65 passenger and 9 crew members on board [5]. Nobody was killed.

**Fig. 7. The Tu-154B1 CCCP-85286 at Stockholm Arlanda Airport on November 14, 1978.**

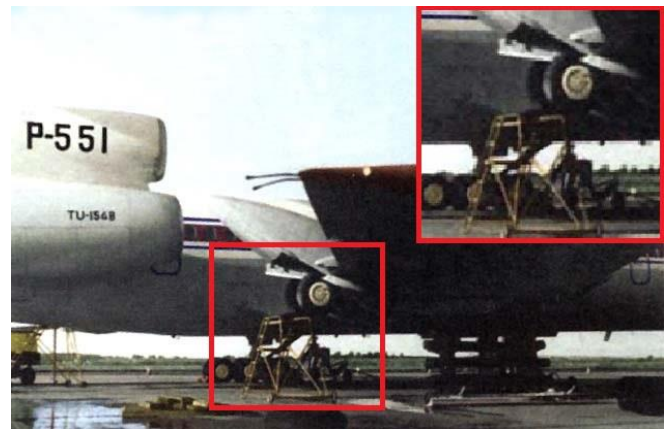
The Tu-154B P-551 passenger aircraft operated by the North Korean airline CAAK departing from Tripoli on June 30, 1979 sustained substantial damage in a landing accident at Budapest-Ferihegy Airport, Hungary (Tab. 8, Fig. 8) [5]. When the pilot realized that the aircraft would undershoot, he raised the nose without applying power. At a speed of 256 km/h the aircraft stalled and landed hard. The right landing gear collapsed and the right wing struck the ground

causing substantial damage to the wing structure [2-5]. There were no fatalities.

**Fig. 8. The Tu-154B P-551 with damaged right landing gear and wings at Budapest-Ferihegy Airport on June 30, 1979.**

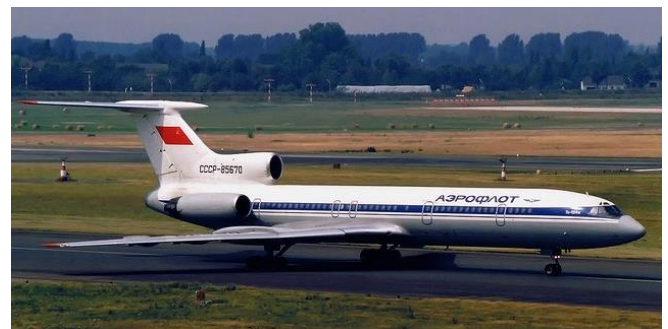
The Tu-154M CCCP-85670 (Fig. 9) while approaching Zurich Kloten Airport on August 23, 1992 (Tab. 10) in conditions of heavy rain and turbulence abandoned the landing and a *go-around* procedure was initiated [3-5]. The aircraft lost some height and collided with a 6 m high antenna, located 650 m from the runway. The inner flaps on

the right wing were damaged substantially and the crew could only carry out a right hand turn instead of a left one as told by ATC<sup>5</sup>. A safe flapless landing was made with no injuries to 136 occupants and 9 crew members. The probable cause could be too late initiated *go-around* and incorrect assessment of the weather conditions by the crew.

**Fig. 9. The Tu-154M CCCP-85670 that collided with antenna at Zurich Kloten Airport on August 23, 1992.**

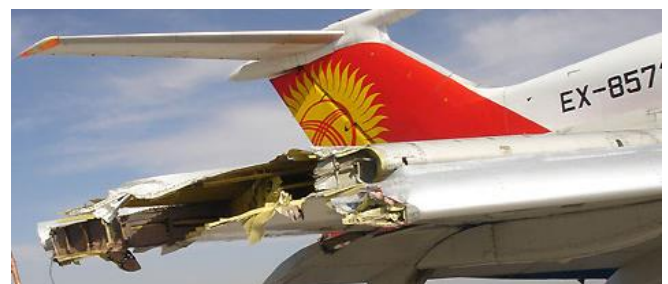
**Fig. 10. The Tu-154M EX-85718 with damaged wing at Manas Airport, Bishkek, Kyrgyzstan on September 26, 2006.**

off. The departing and accelerating aircraft's right wing passed under the outer portion of the KC-135's left wing tip, but clipped and eventually destroyed the No 1 engine (left outboard engine) and a portion of the wing. **Despite losing up to 2,5 m of its outer right startboard wing in the collision (Fig. 10 and Fig. 11), the Tu-154, with 52 passengers and nine crew, became airborne and was able to take off, reach an altitude of about 200 m and circled once before returning to the airport for a successful emergency landing.** The flight of the Tu-154M with broken wing lasted several minutes.

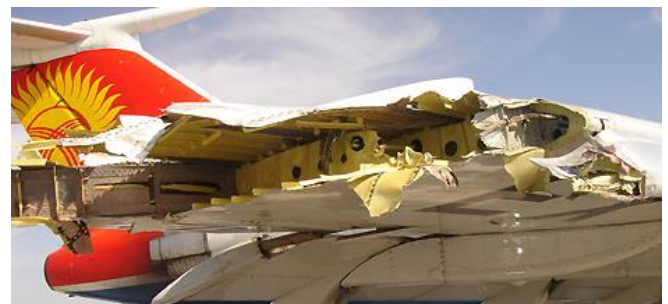
**Fig. 11. Details of the damaged right wing of the Tu-154M EX-85718, which struck the parking KC-135R tanker.**

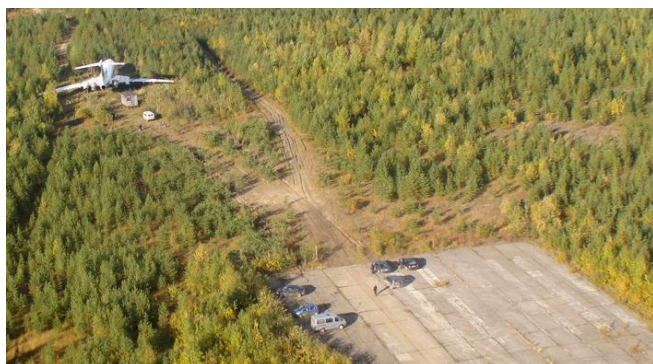
**Fig. 12. Emergency landing of the Tu-154M RA-85684 at old airfield in Izhma, Komi Republic, Russia, Sept. 7, 2010 [8].**

According to investigations, this incident occurred as a result of the failure of the power supply 27 V DC due to thermal damage, i.e., thermal runaway<sup>6</sup> of the on-board

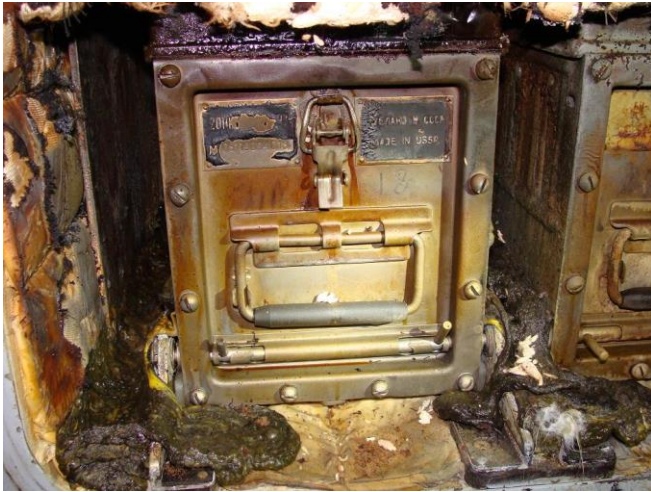
20NKBN-25 nickel-cadmium battery No 1 (Fig. 13) supplying the left DC grid [8, 9, 10,]. It has been found that batteries were used in violation of the maintenance manual. Similar problems were encountered on the Boeing 787 *Dreamliner* flights in Japan and Boston in January 2013 when the lithium-ion batteries got overheating.

Overheated 20NKBN-25 batteries of the Tu-154M RA-85684 failed taking out the entire electric system and caused the failure of all attached systems including navigation and radio equipment as well as all fuel pumps.

Fig. 13. The damaged 20NKBN-25 battery No 1 in the battery compartment of the Tu-154M RA-85684, which landed at Izhma airfield September 7, 2010 [8].

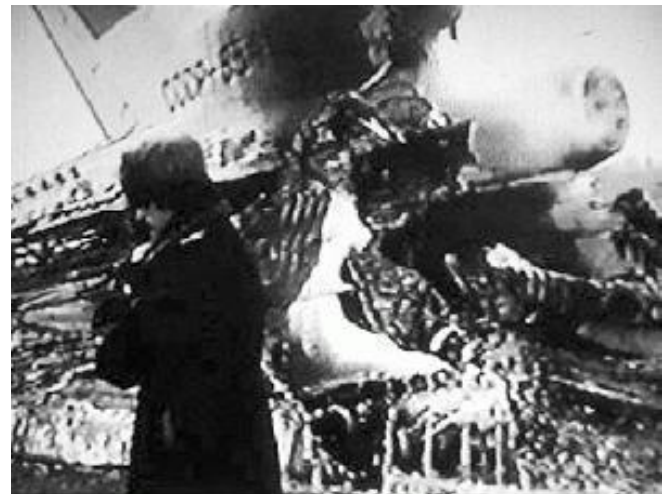
**Fig. 18. Destroyed tail section of the Tu-154B2 CCCP-85413 at Veshchevo air base 100 km northwest of St. Petersburg, March 8, 1988.**

The Tu-154B2, CCCP-85413 (Tab. 3) departing from Irkutsk to Leningrad on March 8, 1988 with 170 passengers on board was hijacked by Ovechkin<sup>10</sup> family (11 people) [2-5]. The hijackers wanted the aircraft to divert to London, but the pilots managed to convince them they would have to refuel to reach that destination. They diverted to Veshchevo, telling the hijackers this was actually an airfield in Kotka, Finland. The aircraft was stormed by Soviet security forces. A bomb exploded causing severe damage to the tail of the aircraft (Fig. 18). Five of the hijackers, 3 passengers and one female flight attendant have been killed [2-5].

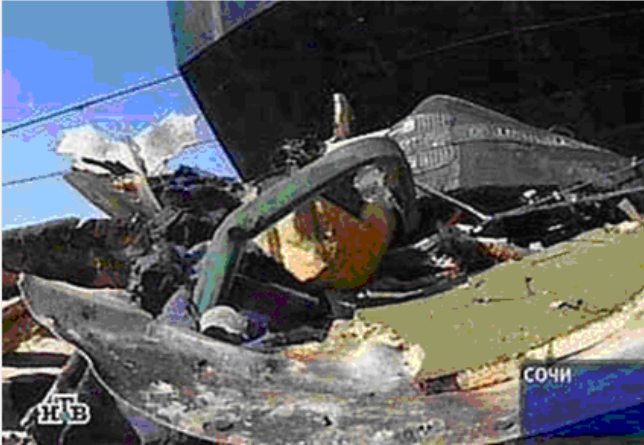
**Fig. 19.** Remnants of the Tu-154M RA-85693 lifted by a rescue vessel.

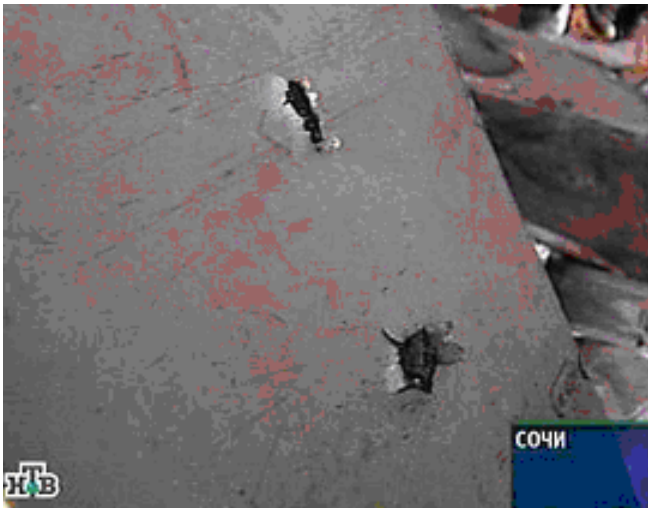
**Fig. 20.** Holes found in the fuselage and other fragments of the Tu-154M RA-85693 can be identified as a shrapnel trace of antiaircraft missiles.

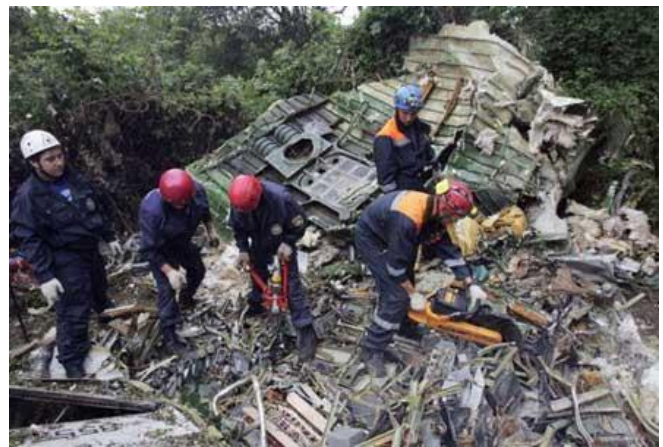
**Fig. 21.** Remnants of the Tu-154B2 RA-85556 on the crash site.

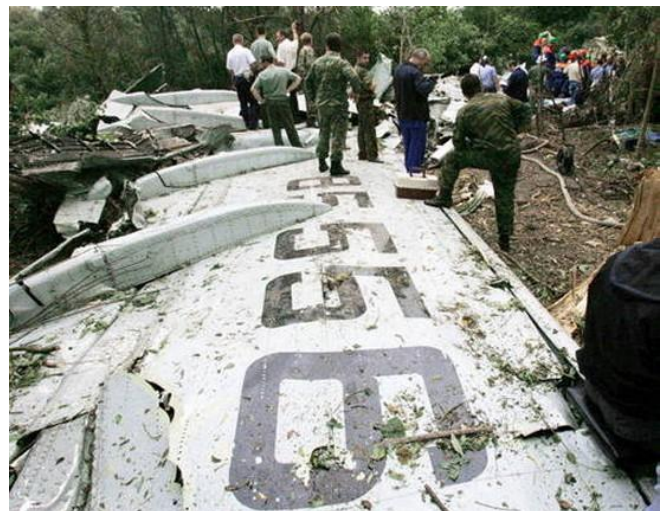
**Fig. 22.** Left wing of the Tu-154B2 RA-85556 on the crash site.

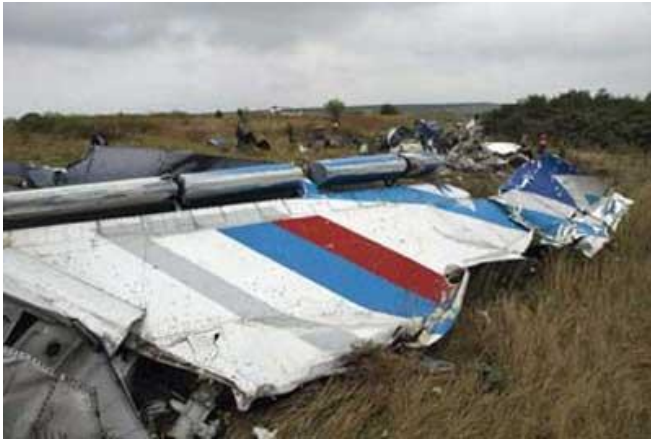
Fig. 23. Rudder of the Tu-154B2 RA-85556 on the crash site.

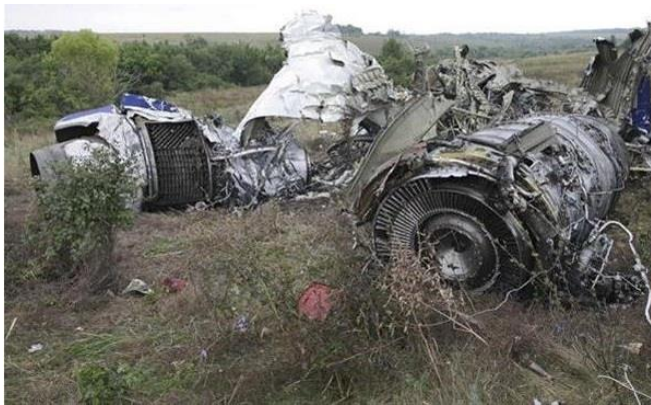
Fig. 24. Turbofan engines Kuznetsov NK-8-2 of the Tu-154B2 RA-85556 on the crash site.

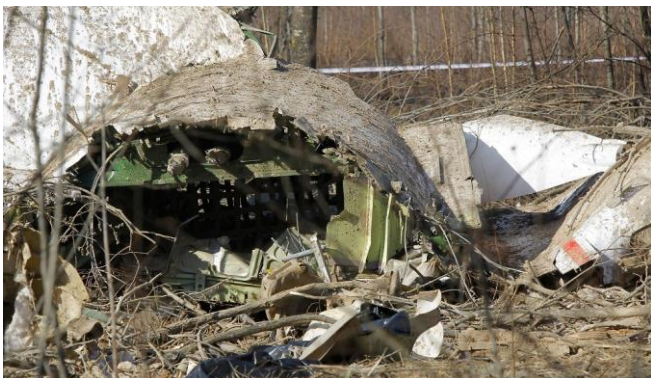
- mid section of the fuselage with its walls split in longitudinal direction and open to the outside (Fig. 25);
- separation of the rear section of the fuselage around the frame No. 65 due to action of axial force (Fig. 26).

Fig. 25. Split skin of the fuselage (resting upside down) of the Tu-154M PLF 101 along its longitudinal axis and rolled out.

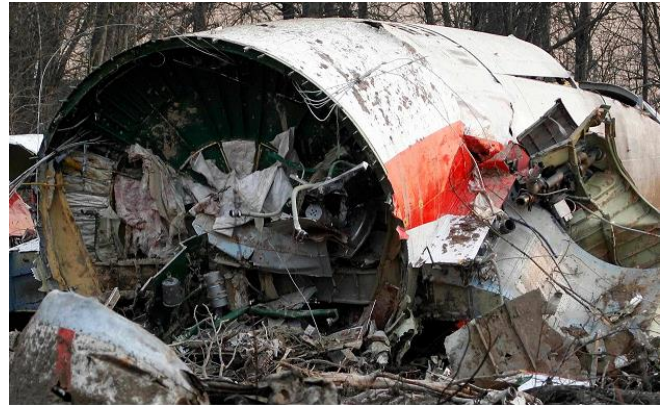
Fig. 26. Rear part of fuselage of the Tu-154M PLF 101 torn around the frame No. 65 with broken bolts.

In the case of explosion in a thin-wall cylindrical vessel, its closed ends can be also torn down. Typical example of such explosion is rupture of truck tank with liquefied petroleum on February 20, 2012 in Northern China (Fig. 30). Inner forces in longitudinal direction have torn the closed ends off the cylindrical section. Similar action of inner axial forces can be observed when the rear portion of the fuselage is separated from the mid fuselage, e.g. Fig. 26.

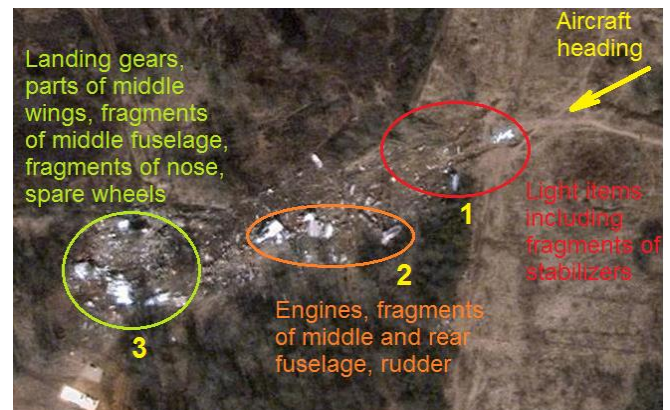
Fig. 27. The Tu-154M PLF 101 wreckage trail plot grouped by location of parts of the aircraft: (1) light items including fragments of stabilizers; (2) engines, fragments of middle and rear fuselage, rudder; (3) landing gears, parts of middle wings, fragments of middle fuselage, fragments of nose, spare wheels.

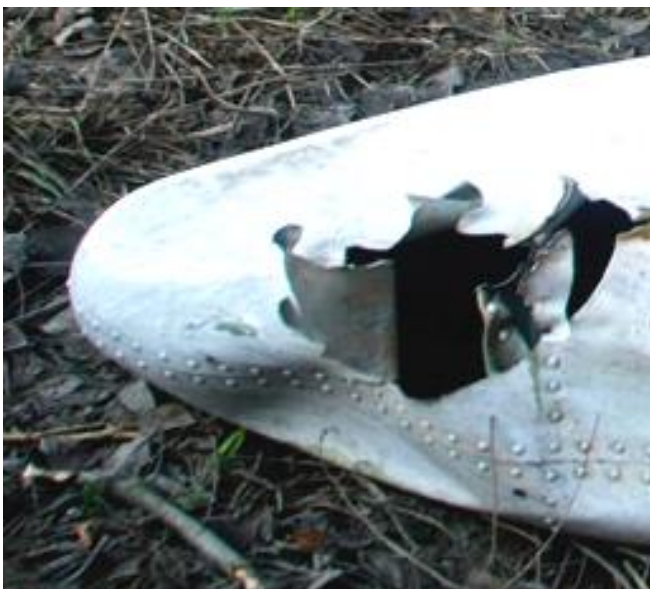
Fig. 33. Petaled hole with rolled edges in a wing part (probably wing fairing) of the Tu-154M PLF 101 found near crash site. This hole is not a full evidence of explosion because no other symptoms of explosion as, for example, tensile rivet failure, staining, impact craters, etc., are visible. Source: [http://inapcache.boston.com/universal/site\\_graphics/blogs/bigpicture/poland\\_04\\_12/p03\\_22969387.jpg](http://inapcache.boston.com/universal/site_graphics/blogs/bigpicture/poland_04_12/p03_22969387.jpg)

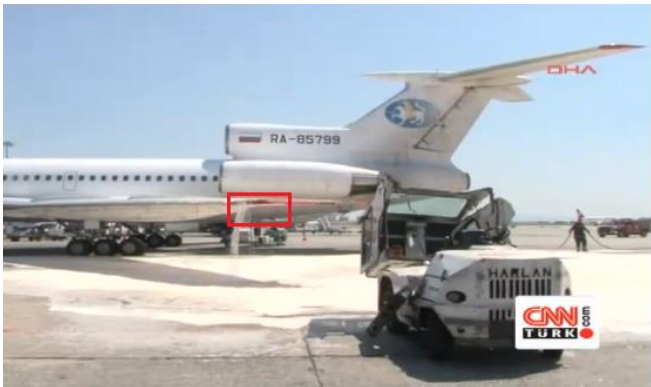
Fig. 44. Tu-154M RA-85799 and luggage truck after collision at Istanbul Ataturk airport on July 27, 2011. Source: <http://www.euromag.ru/turkey/11679.html>.

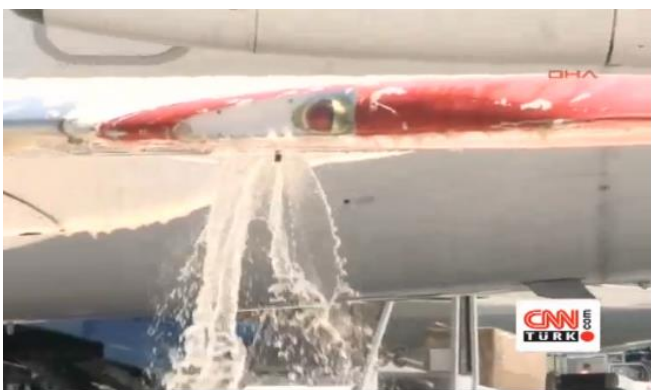
Fig. 45. Fuel leakage from the damage tip wing of the Tu-154M RA-85799 at Istanbul Ataturk airport on July 27, 2011. Source: <http://www.euromag.ru/turkey/11679.html>

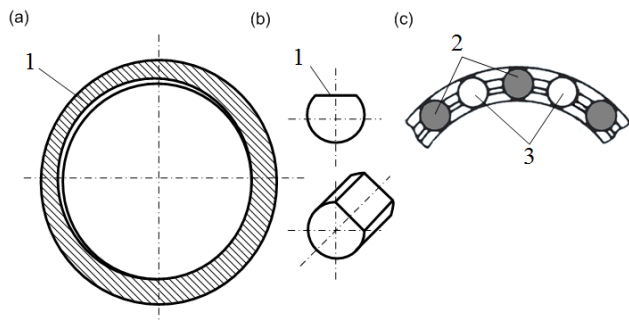
**Fig. 48.** Destruction of inter-shaft bearing (part 2 in Fig. 47): (a) outer race of bearing, (b) roller of bearing, (c) cage with incomplete rollers. 1 - wear of material, 2 - rollers, 3 - no rollers.
