# ANALYSIS OF ACCIDENTS OF THE TU-154 AIRCRAFT

Jacek F. Gieras

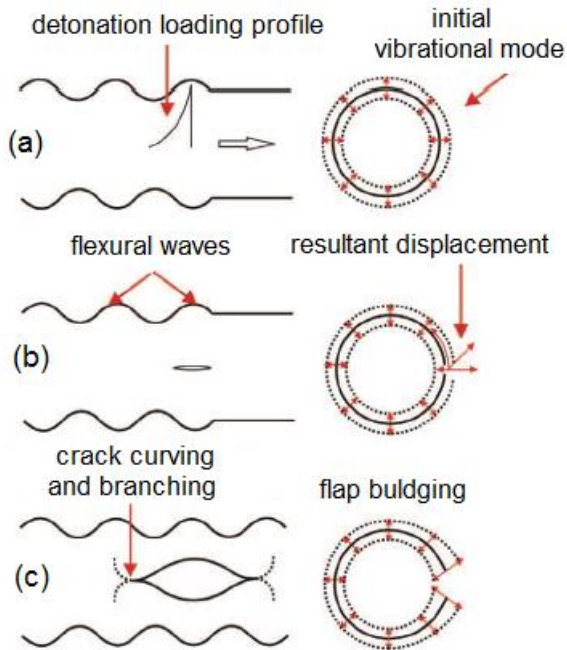
Fig. 28. Cyclic crack growth in a tube: (a) moving detonation front; (b) formation of flexural waves; (c) flap bulging, curving, and branching [20].

One of the most important questions that arouse during the accident investigation is whether the type of accidental combustion can be deduced from the fracture patterns [20]. It has been recently proved that at high pressure level a major portion of crack growth under the influence of fluctuating stresses is periodic (Fig. 28) [20]. The passage of detonation front results in a pattern of fluctuating hoop strains. Large tensile stresses develop in the bulged region in the axial direction of the tube causing a rupture of the tube (Fig. 28) [20]. Examples of confined ruptures of

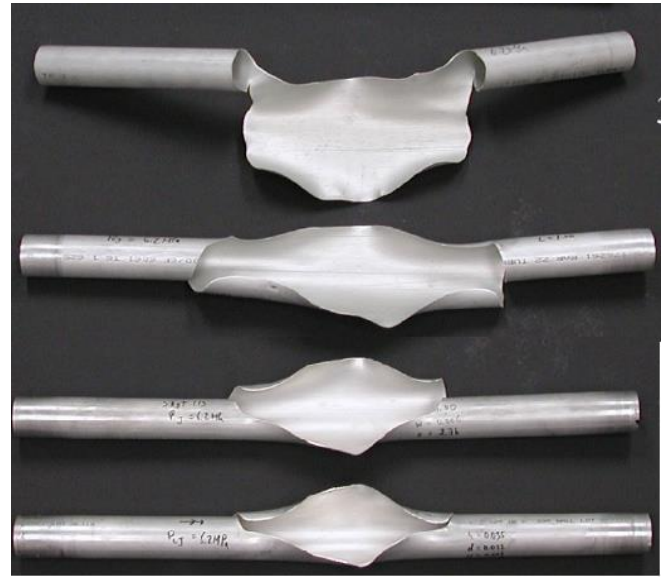
experimental aluminum tubes under internal gaseous detonation are shown in Fig. 29 [28].

Fig. 29. Examples of confined ruptures of experimental aluminum tubes under internal gaseous detonation [28].

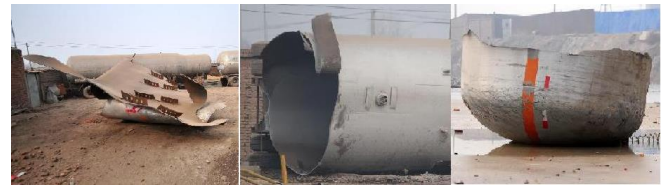
Fig. 30. Explosion of liquefied petroleum in truck tank, Xigu District of Lanzhou, Gansu Province, China on February 20, 2012. Source: [http://www.china.org.cn/photos/2012-02/21/content\\_24689788.htm](http://www.china.org.cn/photos/2012-02/21/content_24689788.htm)

In the case of explosion in a thin-wall cylindrical vessel, its closed ends can be also torn down. Typical example of such explosion is rupture of truck tank with liquefied petroleum on February 20, 2012 in Northern China (Fig. 30). Inner forces in longitudinal direction have torn the closed ends off the cylindrical section. Similar action of inner axial forces can be observed when the rear portion of the fuselage is separated from the mid fuselage, e.g. Fig. 26.

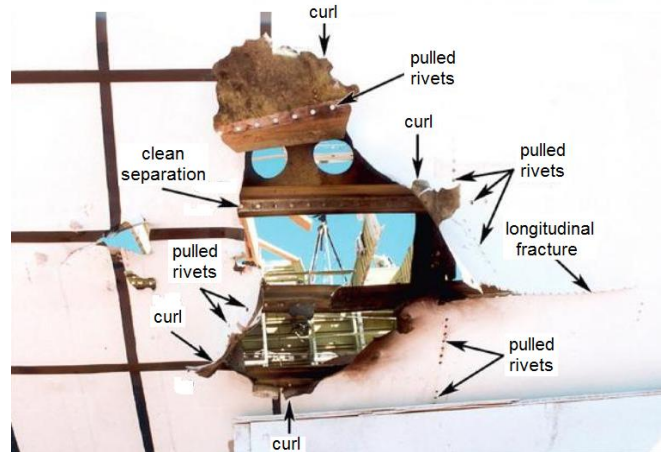
Fig. 31. Exterior view of a petaled hole in the fuselage skin of an unpressurized B-747 aircraft following the detonation of IED installed in luggage container. A longitudinal fracture originates from the hole [17].

An improvised explosive device (IED) usually used by terrorists, when detonated, creates a petaled hole in the fuselage skin (Fig. 31) [17]. Portion of the skin roll out and tear away from the center of the rupture, creating curls, as post-blast gases vent [17].

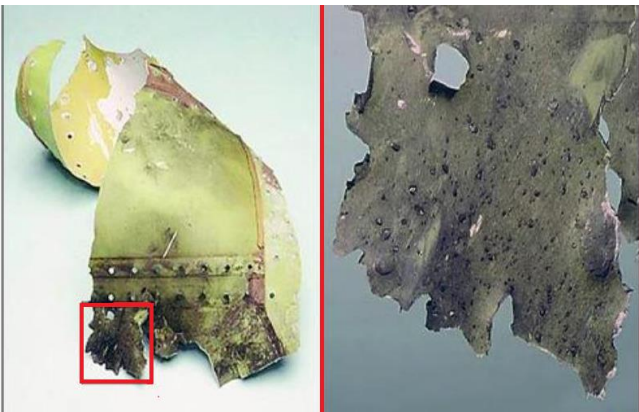
Fig. 32. Good example of explosive signature that shows pulled rivets, staining, microcraters, petaled hole, rolled edges (curl) and gas wash in the skin of an aircraft fuselage [17].

The size of the piece of evidence is not important because it always is a sufficient proof of explosion [14]. If there is 100% guarantee that the given piece really comes from the aircraft under investigation, only one *signature* on a single item is sufficient [14]. One signature is understood as a series of distinctive marks characteristic for explosion (Fig. 31 [17]).

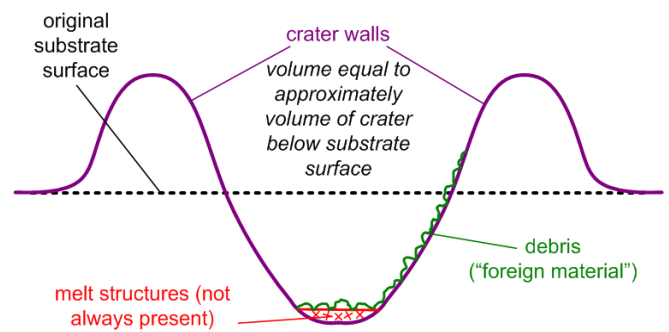
Fig. 34. Structure of impact crater created in metal parts as a result of explosion [17].

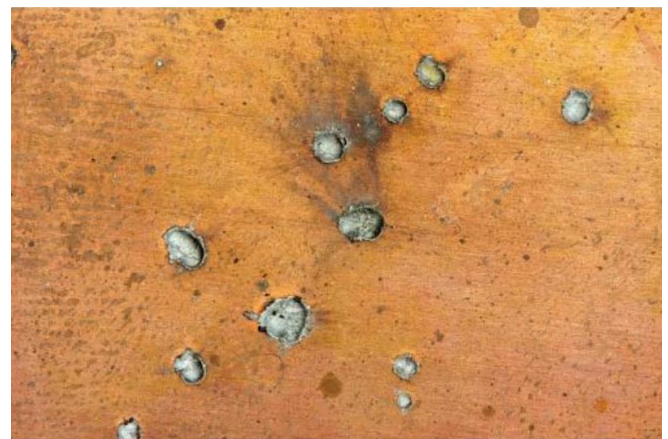
Fig. 35. Experimental explosive cladding: aluminum deposited on a copper sheet. Craters are formed explosively [14].

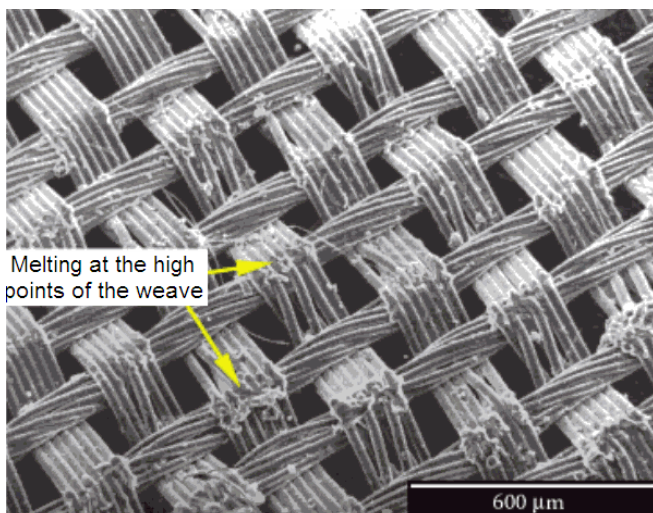
Fig. 36. Explosive flash melting on nylon [14].

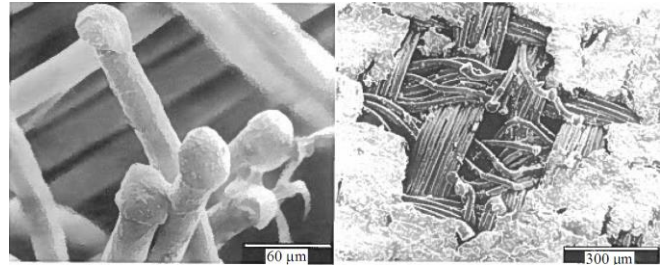
Fig. 37. Globularizing of fiber ends [14].

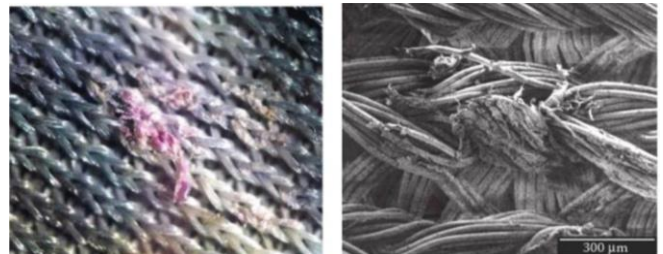
Fig. 38. Interpenetration of fabrics [14].

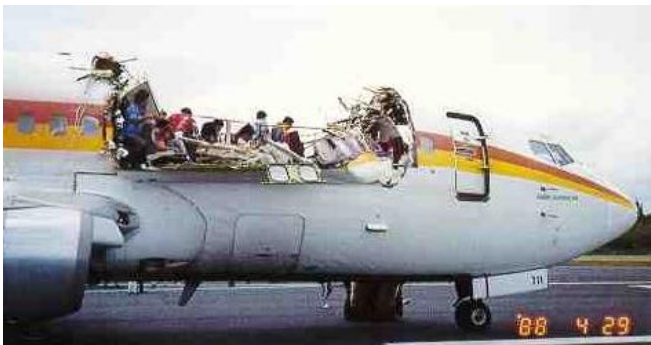
Fig. 41. Open fuselage of the Boeing 737 Aloha Airlines, Flight 243, April 28, 1988 due to cracks along riveted paths. Source: <http://deicinginnovations.com/wp-content/uploads/2012/07/Aloha.jpg>

On April 28, 1988 a 19-year old Boeing 737-200, operated by Aloha Airlines as Flight 243 lost a major portion of the upper fuselage at 7300 m while en route from Hilo, to Honolulu, Hawaii (Fig. 41). The pilot performed an emergency descent and landed at Kahului Airport on the Island of Maui. There were 89 passengers and 6 crewmembers on board. One flight attendant was swept overboard during the decompression. Multiple fatigue cracks were detected in the aircraft structure in the holes of the upper longitudinal row of rivets on several fuselage skin lap joint paths.

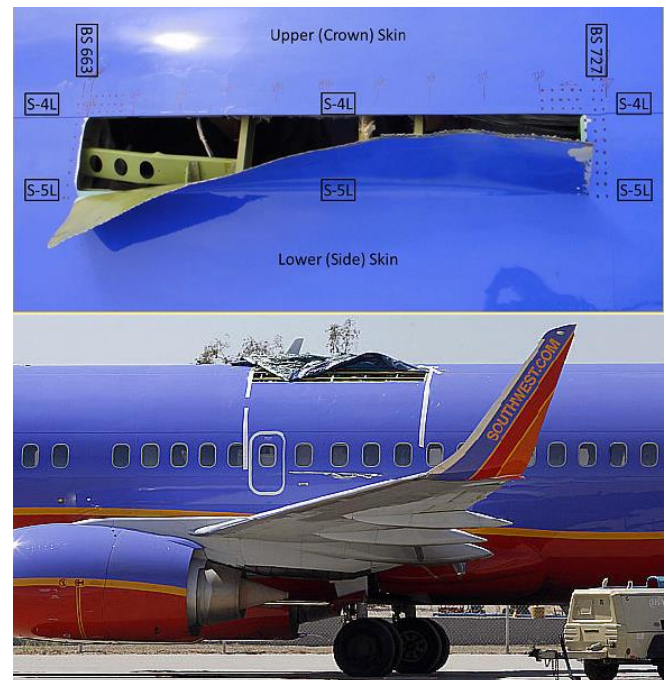
The rip in the roof (Fig. 42) of the 15-year old Boeing 737-300 aircraft caused rapid loss of pressure in the cabin of Southwest Flight 812 that had just taken off from Phoenix, AZ for Sacramento, CA on April 1, 2011. Pilots quickly descended from 11000 m and safely landed the damaged

Fig. 42. Roof of the Boeing 737-300 Southwest Airlines Flight 812 with 1.5-m long rip, April 1, 2011. Source: <https://www.scientificamerican.com/article.cfm?id=southwest-airplane-aluminum-cracks>.

The investigators of the National Transportation Safety Board (NTSB) have found cracks in portions of the lap joint running on two lines of riveted paths covering the length of the fuselage of the Boeing 737-300 involved in the incident.

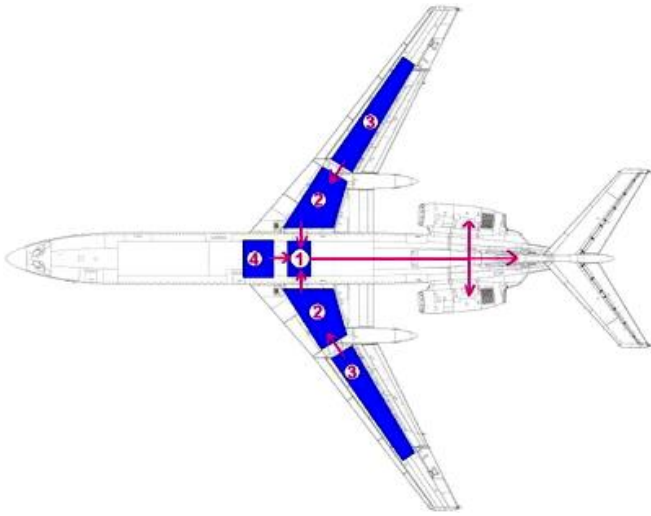
If the Tu-154M PLF 101 hit the birch tree and lost a tip of the wing on April 10, 2010, the outer wing fuel tank would rupture. Location of wing fuel tanks of the Tu-154M is shown in Fig. 43. It is estimated that shortly before the crash, approximately 650 to 725 kg of Jet A-1 fuel could be in the left wing outer tank [9]. Assuming the average fuel density at 15°C as 800 kg/m<sup>3</sup>, the volume of fuel amounted to 812 to 906 l. Such large amount certainly would leave some traces of fuel in the nearest vicinity of the tree and on the path from the collision with tree to the crash site.

Fig. 43. Fuel tank configuration of the Tu-154M: No 1 - center wing tank (CWT), i.e., collector tank, No 2 - inner left and right wing tank, No 3 - outer left and right wing tank, No 4 - additional tank.

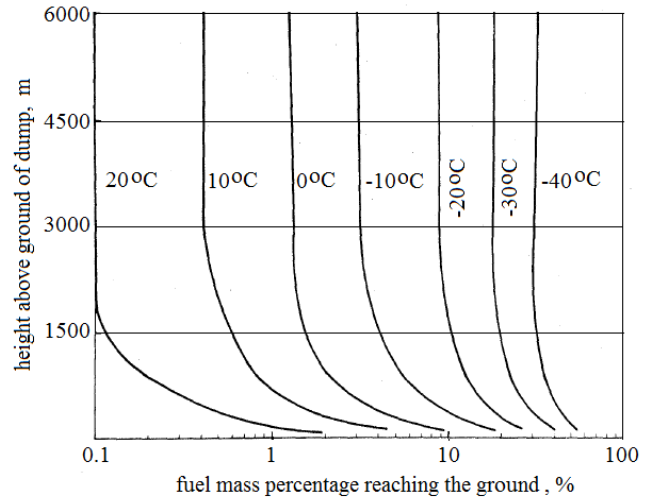
(USAF) [36] fuel jettisoned above 1500 to 1800 m will completely vaporize before reaching the ground. The outside air temperature is very important factor. Fig. 46 shows the percent of fuel mass JP-4 reaching the ground as a

Fig. 46. Percentage of JP-4 liquid fuel drops predicted to reach the ground as a function of dump altitude and ground temperature [37].

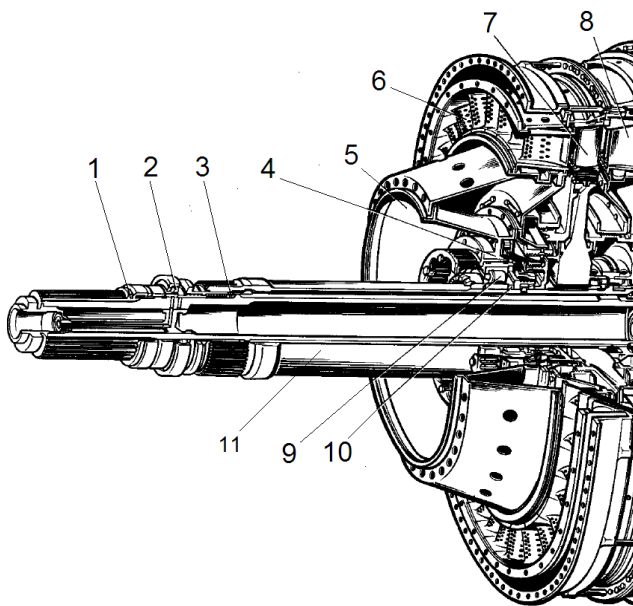
The weakness of construction of the D-30KU engine is the inter-shaft bearing joint between the shaft of the low-pressure turbine (LPT) and the shaft of the compressor fan (Fig. 47). This joint is difficult to access and to provide suitable sealing and intensive oil cooling. In this bearing the Russians removed every second roller (13 rollers out of 26) in the cage and drilled 3 holes in the inner race in order to create oil ducts [35].

**Fig. 47** Portion of turbine of the DK-30KU turbofan engine: 1, 3, 10 - adjustment ring, 2 - inter-shaft bearing, 4 - support bracket of the high pressure turbine (HPT), 5 - eccentric adjustment ring, 6 - inlet guide vane (IGV) for the HPT, 7 - rotor of the 1st stage of the HPT, 8 - 2nd stage vanes, 9 - 3rd stage vanes, 11 - shaft of the rotor of the LPT.
